**COMMERCIAL BUILDING SURVEY**  
**OF**  
**The Tudor Rose Club,**

**FOR**  
**Mr S**

Firstly, may we thank you for your instructions of 28 November 2003; we have now undertaken a Commercial Building Survey (formerly known as a Structural Survey) of the aforementioned property. This Survey was carried out on 28 November 2003.

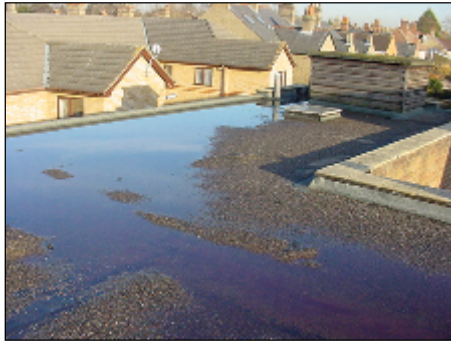
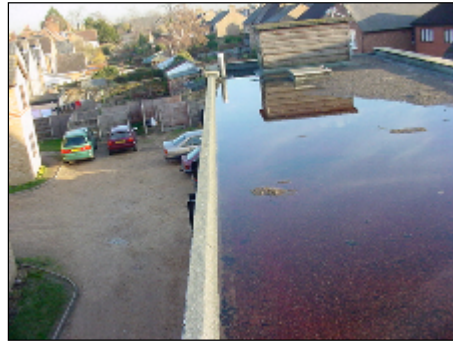
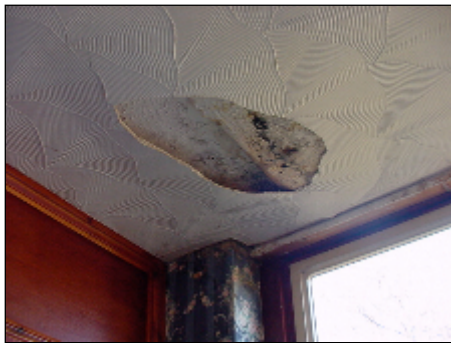
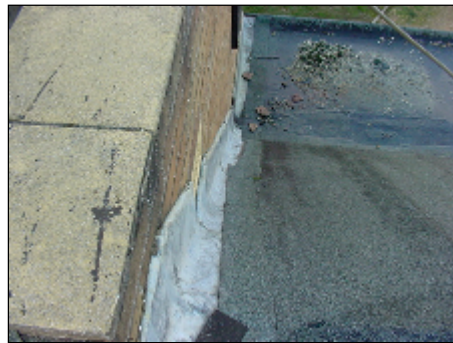
The main roof is a flat bitumen roof that is leaking and has deflected. There was also ponding on the roof at the time of our inspection. We believe the best way to resolve the roof issues are to use an insulation cut to falls (to aim any rainwater at the outlets) and then to re-felt with a high performance elastomeric-type felt. The flashings will also need checking, as will the parapet walls in general.

**ACTION REQUIRED:** The main roof needs re-roofing with falls adding to it, the lower roof can be patch repaired initially with future re-roofing and the lower right hand roof can also be patch repaired in the short-term.

**ANTICIPATED COST:** In the region of £25,000 - £30,000 (twenty five thousand pounds to thirty thousand pounds). We recommend that you get estimates on this from a suitably qualified roofing company that specialises in flat roofs before you proceed with the purchase of the property.

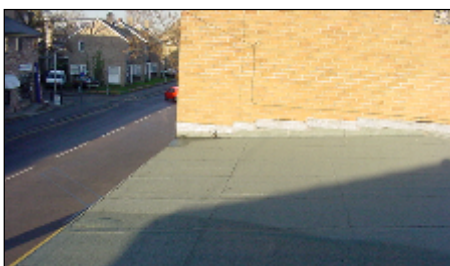
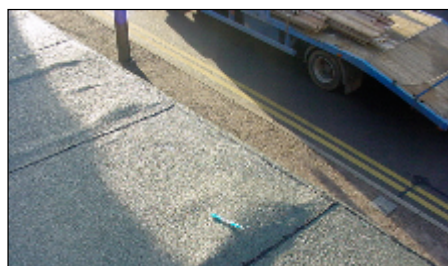
### The Lower Single Storey Roof

The lower roof has a traditional double-pitched roof, although with a fairly minor fall on it. This roof has a mineral felt covering, which has been put on fairly badly and has now blistered and it can be seen where repairs have been carried out, particularly around the junction where it meets the main building. In the long term this will need re-roofing, however we feel on a short-term basis that patch repairs can be carried out and new flashing work. However, it must be understood that the longer the roof is left the more repairs will need to be carried out, for example to the decking beneath it. We are advised that this roof was re-roofed approximately eight years ago, however the quality of the re-roofing is fairly poor, which is why the problems have occurred.

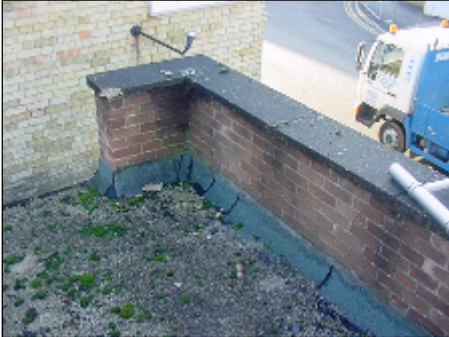
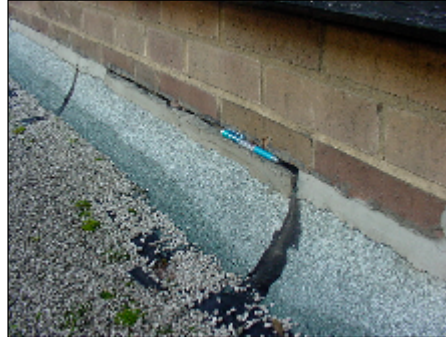
## Far Right Hand Roof

This is a bitumen roof with a chipping finish.

We recommend here that the flashings are repaired and that a layer of chippings are added to the roof to give it protection against the extremes of sunlight and frost.

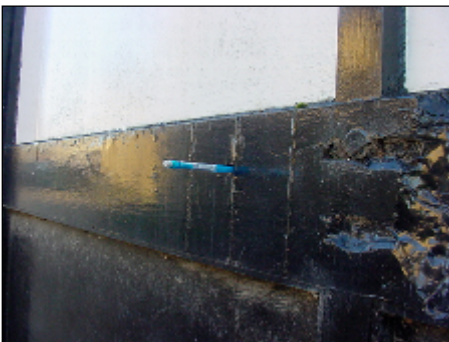
We found rot within the timber frame of the property. This is effectively a cladding because the strength of the property is set out within the steel frame and can be replaced, which does give you the opportunity to make the property more visually appealing/visually dramatic if you so wish, without major costs.

**ACTION REQUIRED:** In due course repair work will be necessary, but first the roof issues and the drainage via the rainwater gutters and downpipes needs to be resolved. These are fairly basic in some instances, such as re-fixing the hopperheads and downpipes.

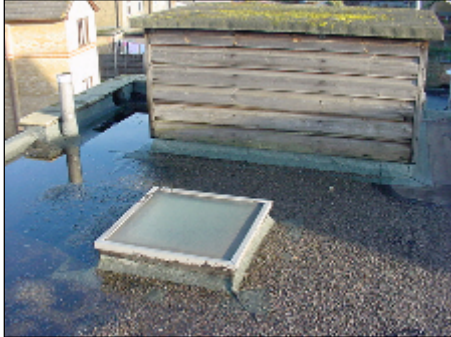
## Water Tank

On the main roof there is a timber clad box section, which we believe hides the water tank within it, this was not opened up.

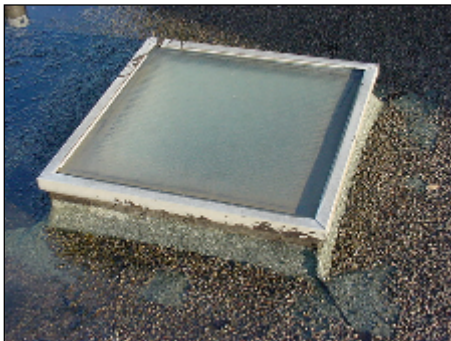
## Roof Light

There is one roof light to the property. It is glazed with a Georgian wire polished plated glass as it should be, although it looks to be single glazed. From the tar that is around it we think it has probably leaked in the past and we tend to find that condensation occurs on these.

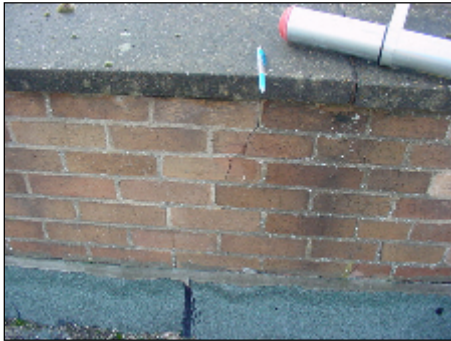
## Far Right Hand Roof

The parapet wall to the far right hand roof is also brick built with a felt flashing, which is coming away in various areas.

In some areas the parapet is exposed on both sides to the weather, this is why we believe the cracking has been caused. Also the drips are not ideal and there will be similar problems to the parapets on the main building.

**ACTION REQUIRED:** Re-bed the flashing or better still replace with a lead flashing.

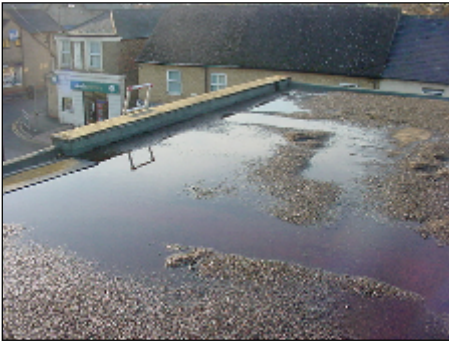
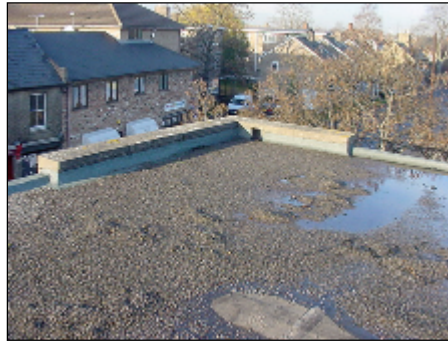
This is a bitumen felt roof with a chipping covering to protect it from frost and sun heat. We believe that it is probably the original roof covering that has had little alteration or repair work carried out on it over the years. It is coming to the end of its useful life, normally considered to be about 30 years and there are signs internally of dampness getting through the roof. We feel there are two options on this:

We have not opened up this roof, but if we did we would expect to find a timber decking with minimal insulation on a steel frame, possibly with some wet rot in the timber decking.

**ACTION REQUIRED:** On our second reading of this report we feel it is prudent if we open up the structure. We suggest it is opened in two areas. We could widen an existing opening to the roof where the water is getting through and we also need to do a second area at the base of a steel column to examine the condition of this to ensure it is not rusting or fractured in any way.

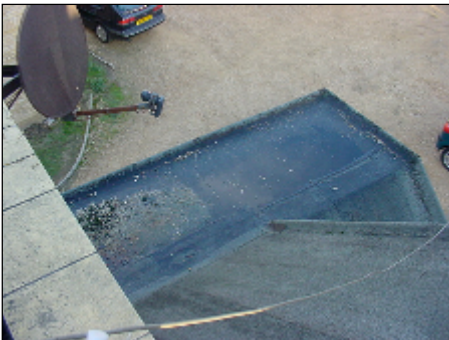
### **Roof to Steps**

At the end of the main roof is the roof over the steps. This roof has a mixed finish, partly of mineral felt and partly of felt with a chipping covering. It is fairly worn and past its best.

**ACTION REQUIRED:** This all needs chippings putting on it, or it may well be cheaper and easier to add an additional layer of felt.

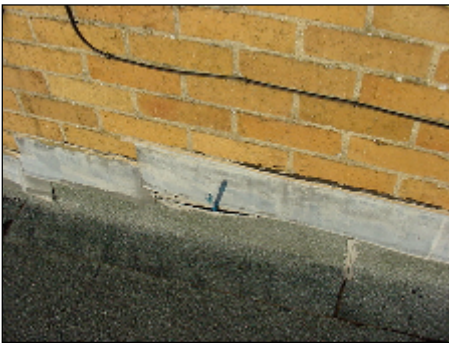
### **Lower Roof**

This roof sits over the bar area and part of the toilets. Again there are visible signs internally that the roof is leaking and also externally we can see that the fairly new mineral felt finish has had various repairs.

1. You can carry out reactive repair when leaks are seen, you may well end up chasing the leaks around, not knowing quite where they are coming from with this technique; or
2. You can carry out repairs to all the flashing and proper repairs to where mastic has been used on the roof and then wait for the blisters to pop, perhaps carrying out an annual check of the roof.

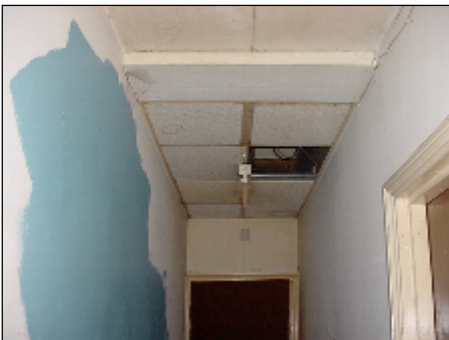
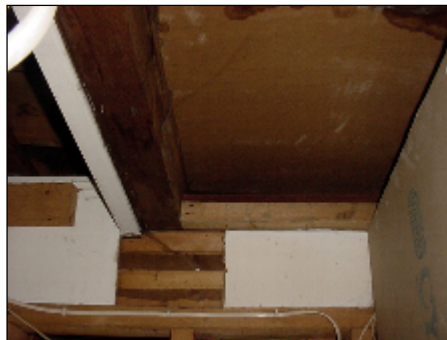
We were able to inspect the low level roofs through the suspended ceiling tiles, although our view was very limited. What we did see was what looked to be a wood decking, this looked to be damp in areas and we did note when walking on it that some areas were particularly spongy, indicating that water is getting through on to the decking itself.

**ACTION REQUIRED:** If you do decide to expose the structure we would also recommend that a selection of the ceiling tiles are removed to gain a better view of the lower roof structure.

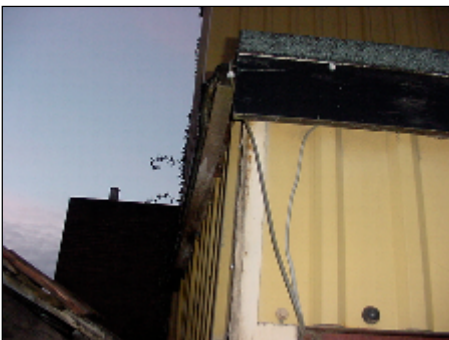
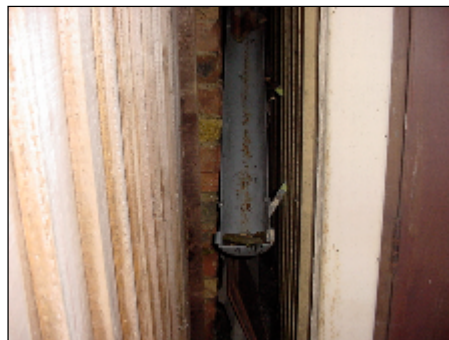
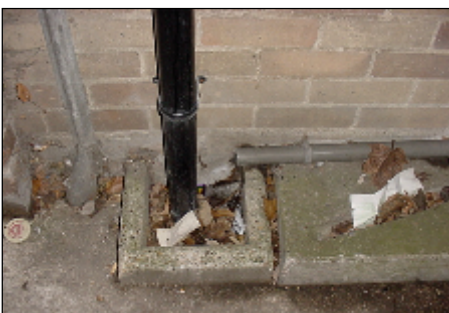
### **Missing Guttering**

To the rear of the property, where the staircase is, the guttering in this section is missing.

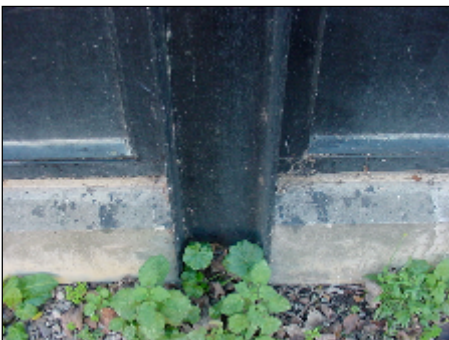
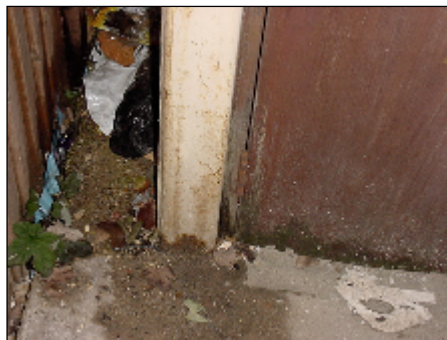
As the main structure is on the frame the areas between it should not be load bearing. The risk with this structure is due to the fact that the roof has been leaking for a while, which could have affected the framework and caused it to rust.

**ACTION REQUIRED:** We would ideally recommend that the structure is opened up, partly to the roof and partly at the base of the structure.

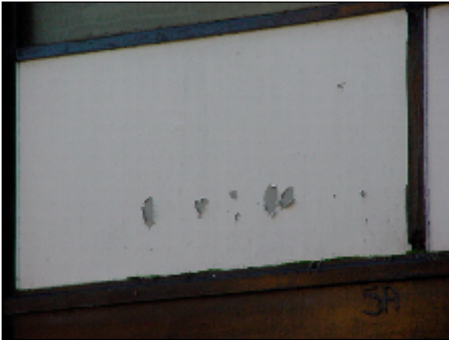
### **Window Sections**

The problem with these is that if they are allowed to deteriorate, get wet or rust they warp and then the windows cannot be opened or shut. At present you have a lot of water discharging down the side of the building due to the gutters not functioning properly. This is why it is essential that the guttering repairs are carried out prior to any work whatsoever being carried out on the outside of the property.

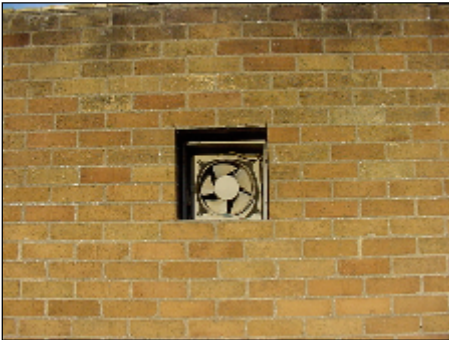
There is an extract fan to the first floor bar; the outer cowling is missing, which is likely to allow water in. When we tried to get the fan to work via the control panel behind the bar it did not appear to be working.

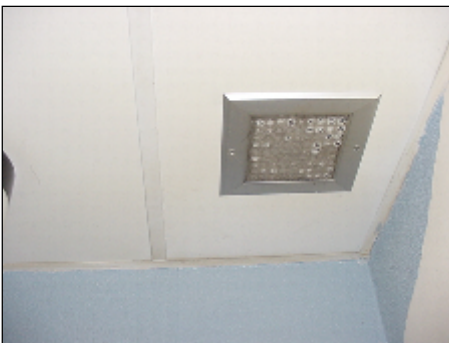
There is also a general air circulation system to areas with the suspended ceiling. The vents to this are desperately in need of a clean.

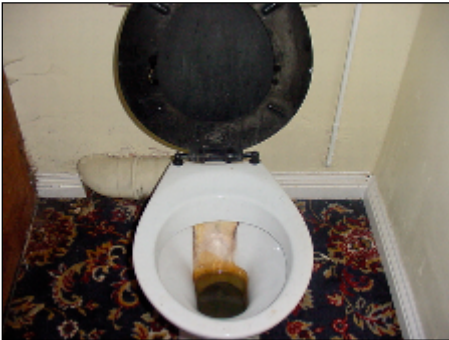
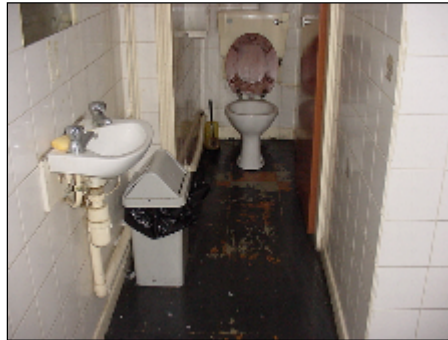
We would describe the ground floor sanitary fittings as well used and abused and the first floor sanitary fittings as in need of some work. To be fair we were only able to access the female toilet on the first floor and we did manage to get the w.c. to flush and the taps to run and a general clear up, together with some ad hoc repairs such as replacing the handle on the w.c. for example, may well be sufficient

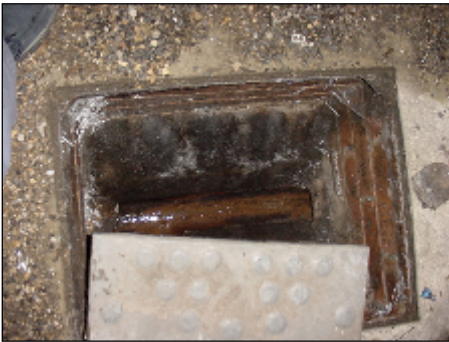
There were also some further manholes that we could not get open. One of which looked to have been rusted in place.

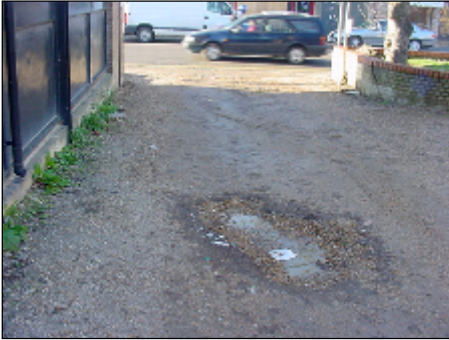
There is a road running up the left hand side of the property. This is worn. We are advised that there is a right of way and you should check to see if there is a responsibility to pay towards the maintenance or even maintain the road.
