SCHEDULE OF CONDITION

The White Hart

The Schedule of Condition has been prepared by www.1stassociated.co.uk in October 2002. The inspection was carried out on Wednesday 9 October 2002 and this report does not constitute a Structural Survey (now known as a Building Survey).

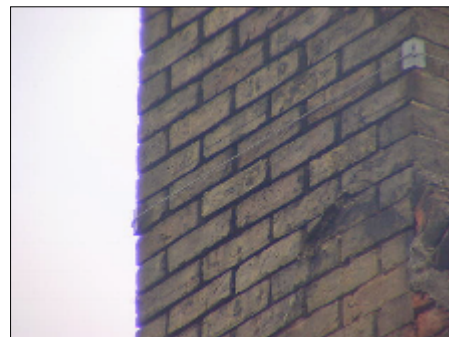
Left Hand Chimney – Chimney One

Slight lean, requires extensive re-pointing and a crack visible.

ACTION: Generally re-point all chimneys, particularly the left hand and right hand side chimneys and new flashings are required for chimneys three and four. Anticipated costs, assuming that scaffolding is not required - £2,000.

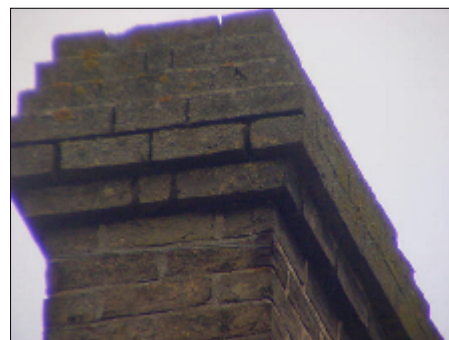
Left Hand Middle Chimney – Chimney Two

Re-pointing.

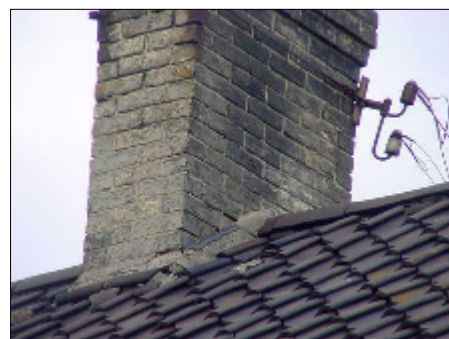
Middle Chimney Right Hand Side – Chimney Three

Requires flashing and some re-pointing.

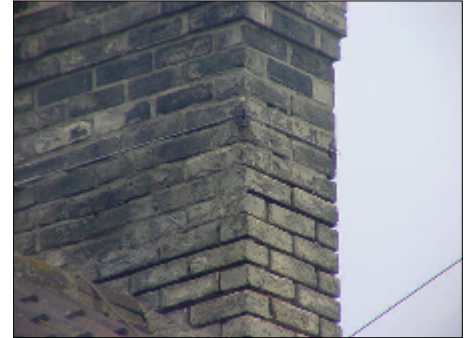
Right Hand Chimney – Chimney Four

Requires extensive re-pointing and new flashing.

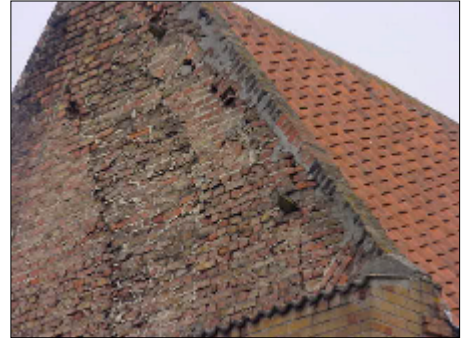
A fairly steep pantile roof in reasonable condition.

The left hand parapet wall is exposed and requires re-pointing or possibly rendering.

ACTION: Re-point approximate cost £2,000 - £5,000 due to the difficulty of access, which will probably require scaffold over the adjoining property.

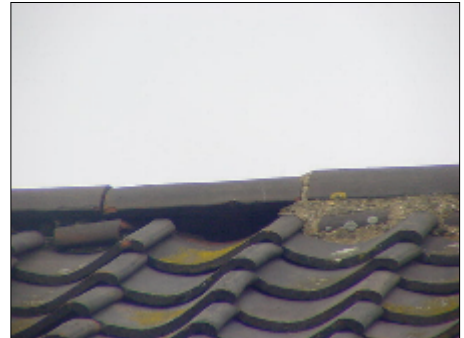
Right Hand Roof – Roof Two

A blackened pantile in average condition. There are some displaced tiles to the left hand side and the ridge requires re-bedding.

Roof tiles require re-bedding

ACTION: Anticipated cost £1,000. This will increase if scaffolding is deemed to be required.

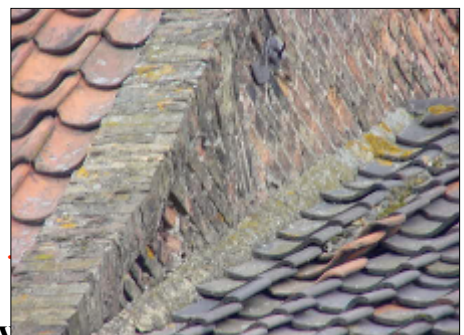
Parapet wall between left and right hand roofs

This requires re-pointing and also has a tile on edge flashing which requires replacing with a lead flashing.

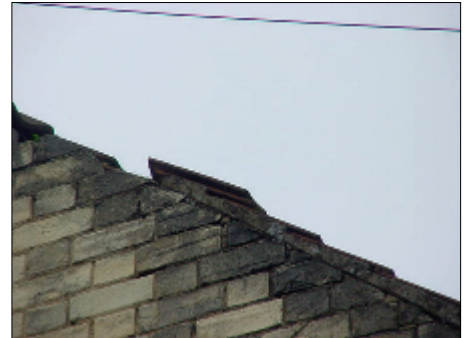
Rear Slate Roof – Roof Three

A slate roof with lead valley gutters, the slate is starting to delaminate and the slates have also been displaced.

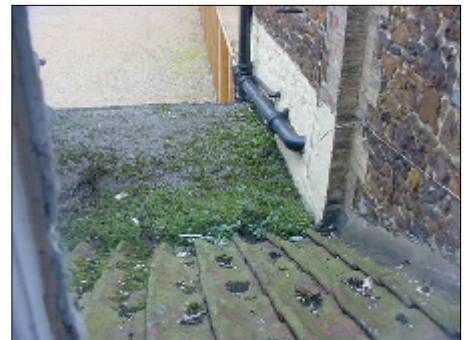
Flat Roof – Roof Four

Moss gathering, indicating that the roof does not have the recommended 12-degree fall.

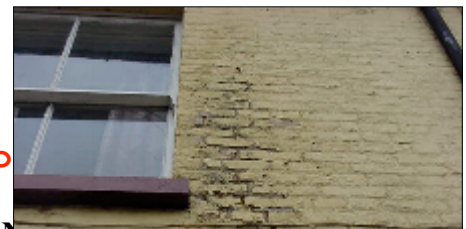
Mixed cast iron and plastic which require renewal, presently allowing water to discharge down the building

particularly to the right hand side of the coach archway which is causing deterioration to the brickwork.

Deterioration being caused by
Leaking gutters

ACTION: We suggest due to the pitch of the roofs, which probably were originally thatched, a deep flow gutter should be used to stop the water overflowing the gutters. Anticipated cost £1,000.

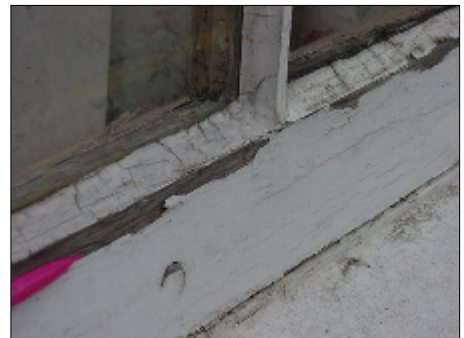
These are flaking and wood is visible in some instances, these require redecoration.

ACTION: Repair and splice in new timber as required and redecorate. Anticipated cost £750.

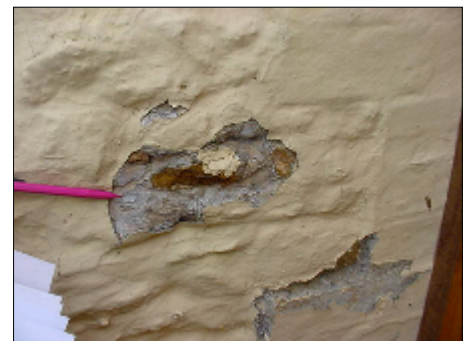
Sandstone

The majority of this has a modern paint on it, which is not recommended and is liable to cause accelerated deterioration to the sand stone.

Spalling has been noted but we do not believe there is any other real alternative without major cost implications, other than to re-paint over the sandstone. The Listed Building Officer may of course feel differently about this!

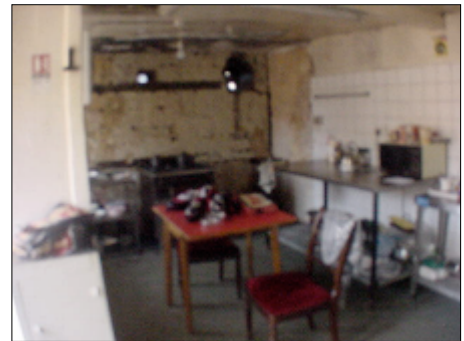
Kitchen

Complete refurbishment needed.

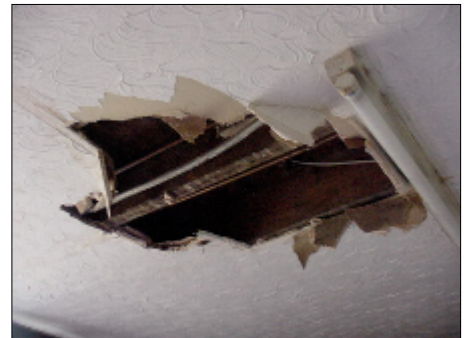
Breakfast Room

The area is generally in need of redecoration and the ceiling needs to be repaired in the breakfast room.

We are concerned with the deflection to the floor in this area. It would appear that the joists are undersized and/or the end of the rafter feet are rotten.

We note this part of the building has been braced both across its width and length and therefore this is a long term problem. We would also advise that this section is the part that has received the listed status.

ACTION: Open up floor to check rafter feet.
