**Prelease  
Schedule of Condition and Want of Repairs  
at  
Milton Keynes  
for  
May**

To carry out Inspection of the Industrial Unit, to identify areas of repair to the Unit at commencement of the Lease.

**Schedule of Condition and Want of Repairs  
at  
Milton Keynes**

Addendum to original Report with photographs

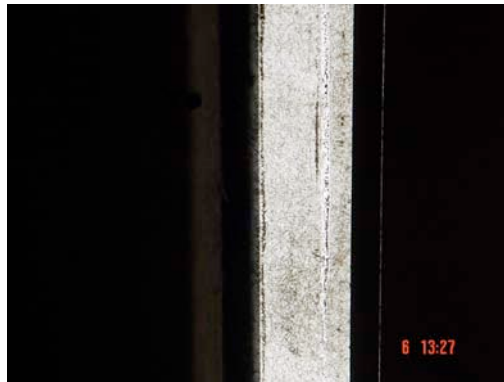
The area has natural light from 28 No.GRP roof lights, in four rows, to the warehouse area only. They are partly dirty, but we could find only two with the possibility of stress, as shown by a bright clear line, in the bottom of the curved sheet, Row 1 No. 7, this appears to have a stain under the stress line which may be a leak, and Row 2 No. 7, the right hand side corner near the Rolling shutters.

These appear to be weaknesses in the GRP roof light, which cause them to need replacement, you will have noticed that one roof light has already been replaced Row 4 No. 7, so we may expect more failure over the next five years.

GRP roof light – note bright line running in trough of light.

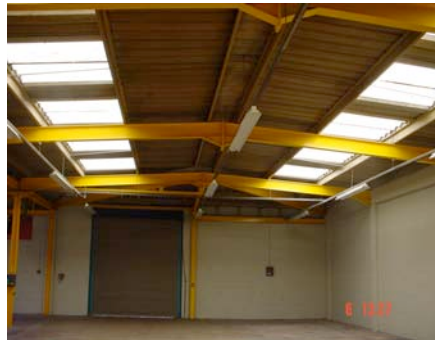
Open Area – Facing Roller shutter door.  
Note. Possible faulty lights - last two in above rows

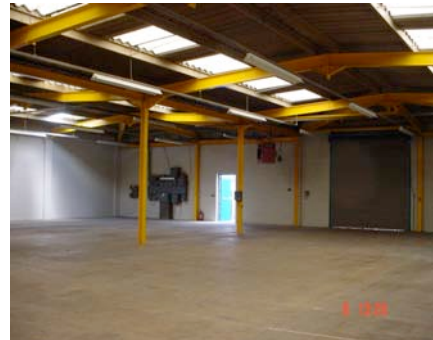
Facing Emergency Exit door.  
Electric Power by Emergency Exit.

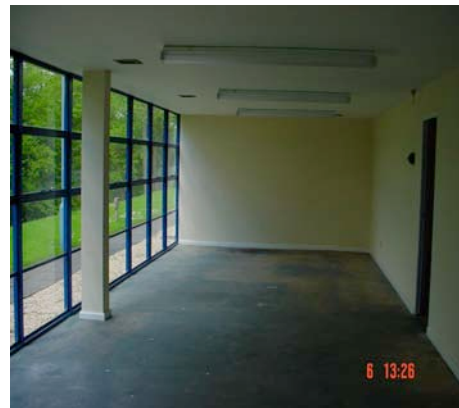
Office with metal windows & glazing to floor level.

The external wall is a metal window glazed curtain wall from floor to ceiling, single glazing, but is not safety glass, as required for glazed doors and side screens and up to 800 mm. from floor level.

The window glazing to the Front door, screen and the Office windows will need to be replaced with safety glass, filmed, or be altered as is the case with the Offices of the local Builders, MF Tofield & Sons , who have had their Unit upgraded with new windows and brickwork below them.

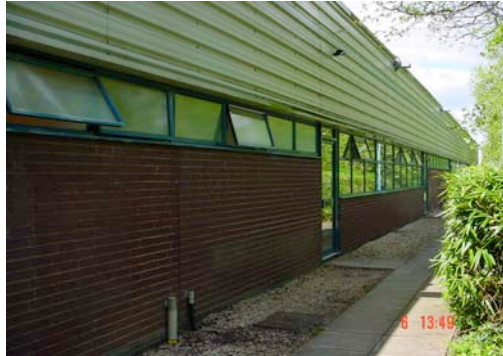
Altered Office windows with brickwork below

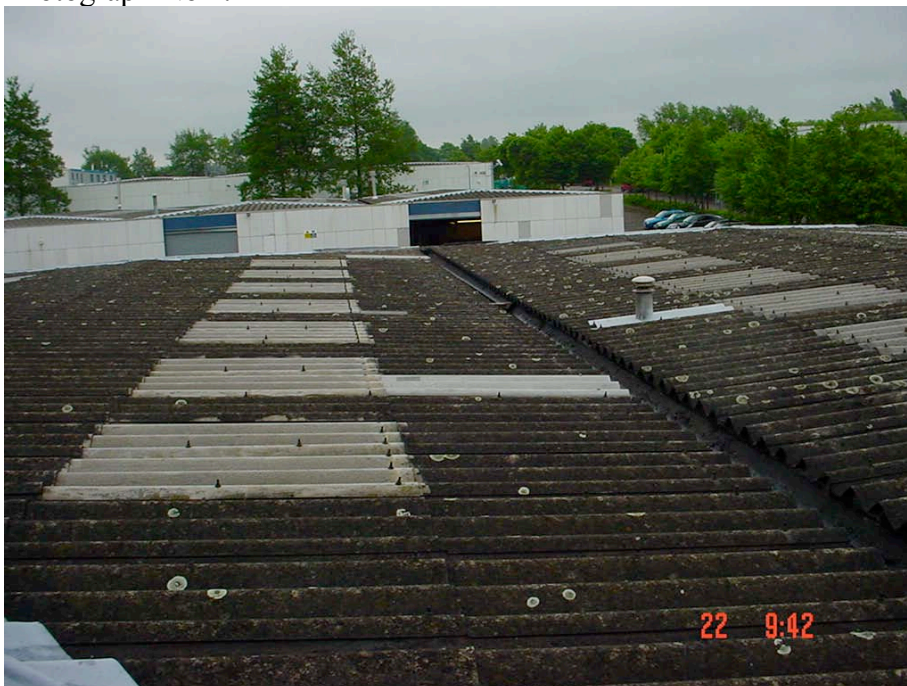
Photograph No 1.

Row 1 Roof lights No 1 – 7 Replaced asbestos sheets by No 2 and No 7.  
Note. Flash band repair by No 4.

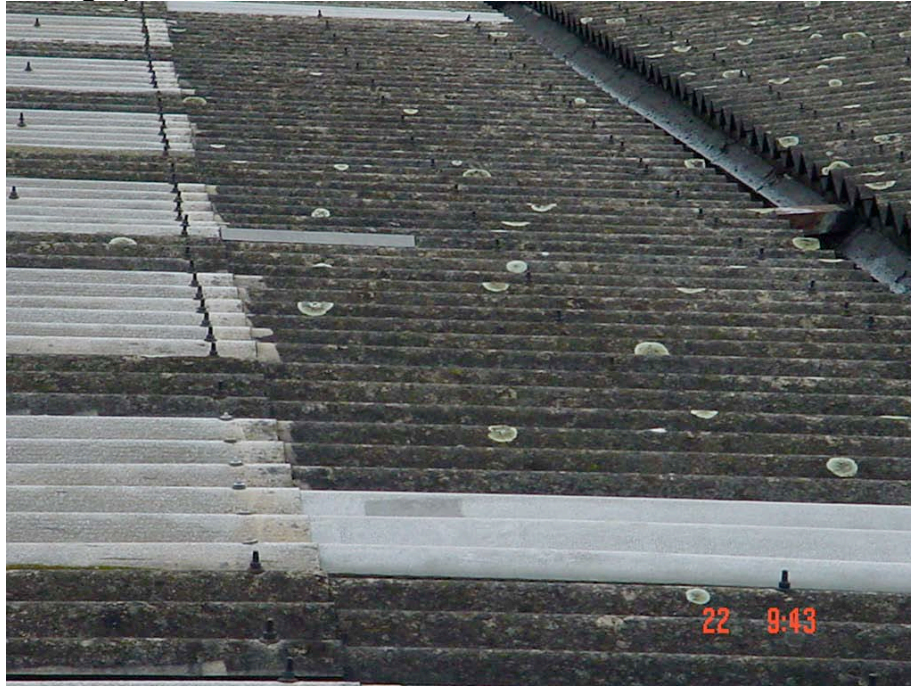
Photograph No 2.

Close up of No 1. Note Possible flash band to replacement asbestos sheet.

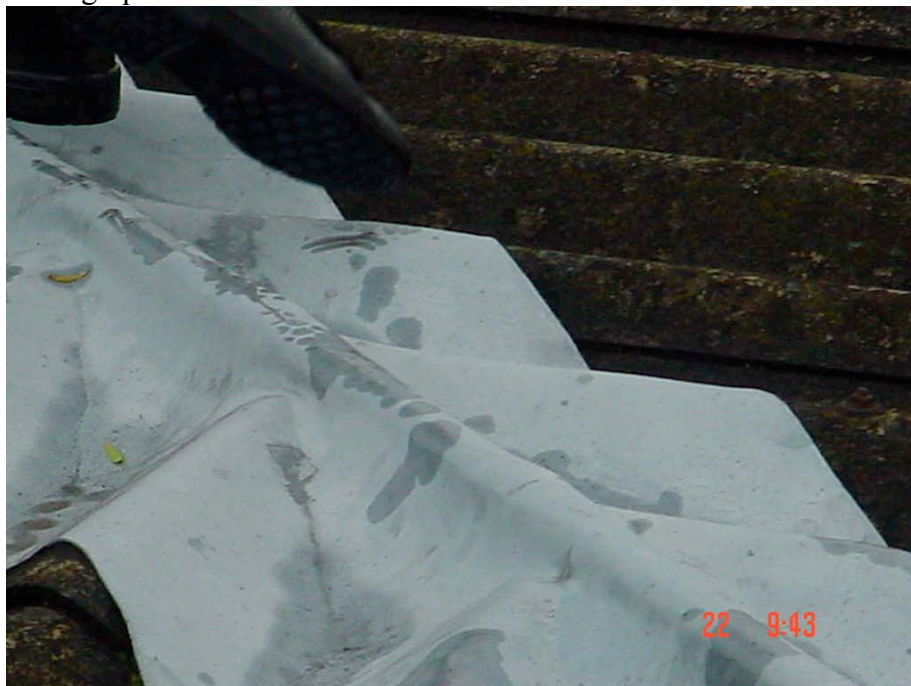
Photograph No 3

Hip to Row 1 [ over Toilets] Lead Hip has split on top of the ridge.  
[1/3rds up from bottom corner]

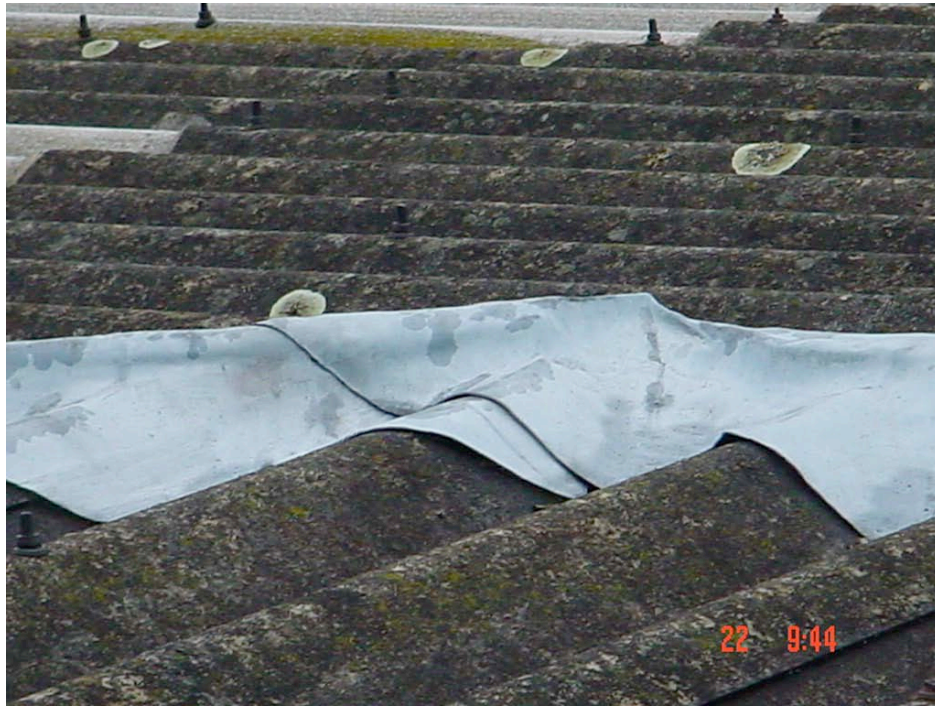
Photograph No 4.

Top of Hip showing poorly dressed lead – could cause splitting.

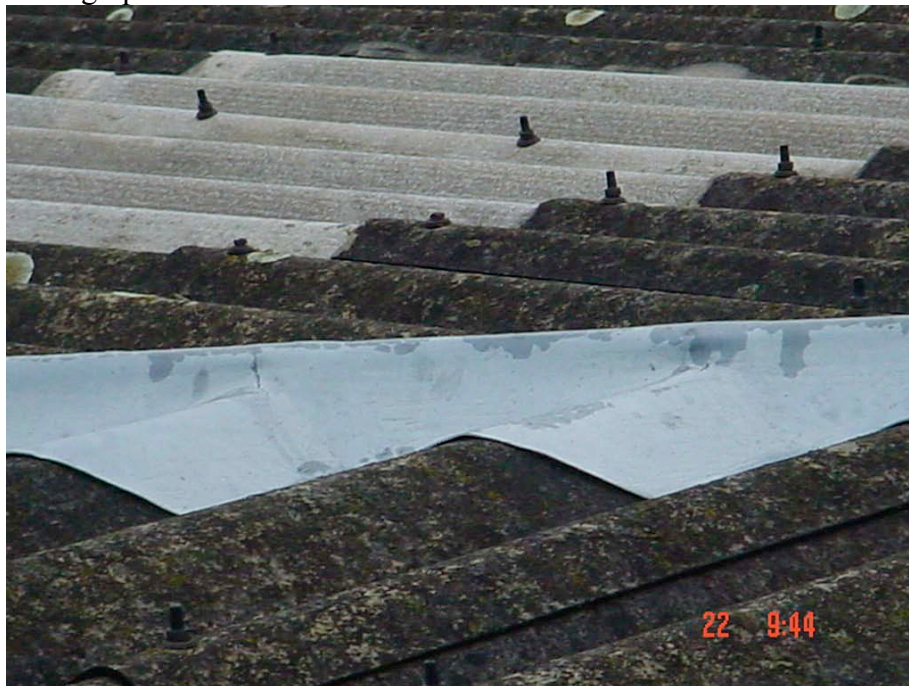
Photograph No 5.

Hip to Row 2. [over Foyer/Toilets] Lead hip with split on ridge.  
[ approximately  $\frac{1}{4}$  up from left hand side]

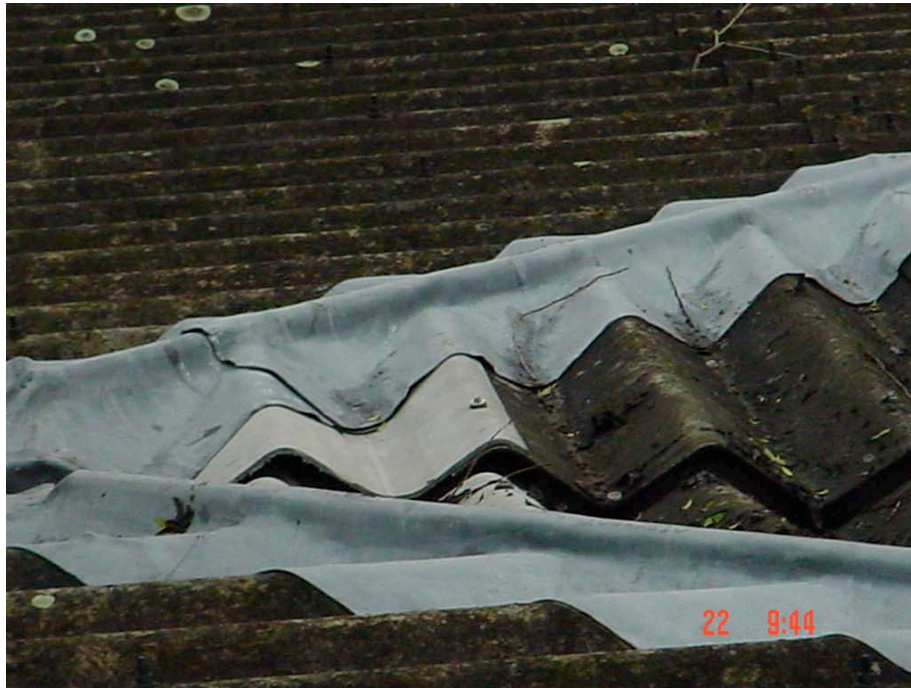
Photograph No 6.

Row 3 Junction of Hips by front Elevation – shows replacement asbestos sheet and redressed hip lead to ridge.

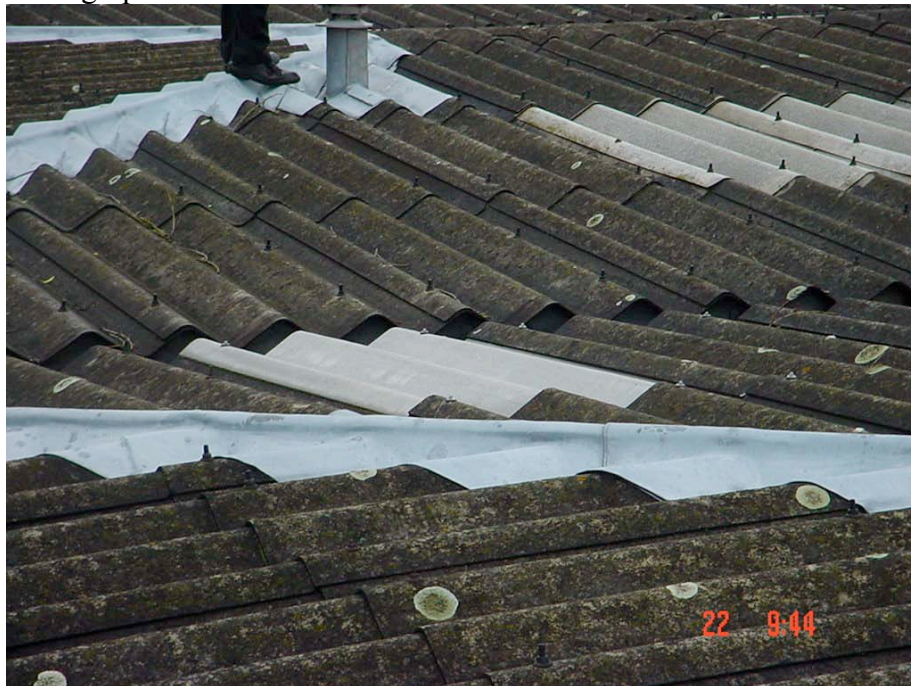
Photograph No 7.

Row No 4. shows replacement asbestos sheet between Roof light No 1 and Front elevation. Note. Chimney to Heater loose [blown off] and vent top to asbestos pipe not fitted [needs new top]

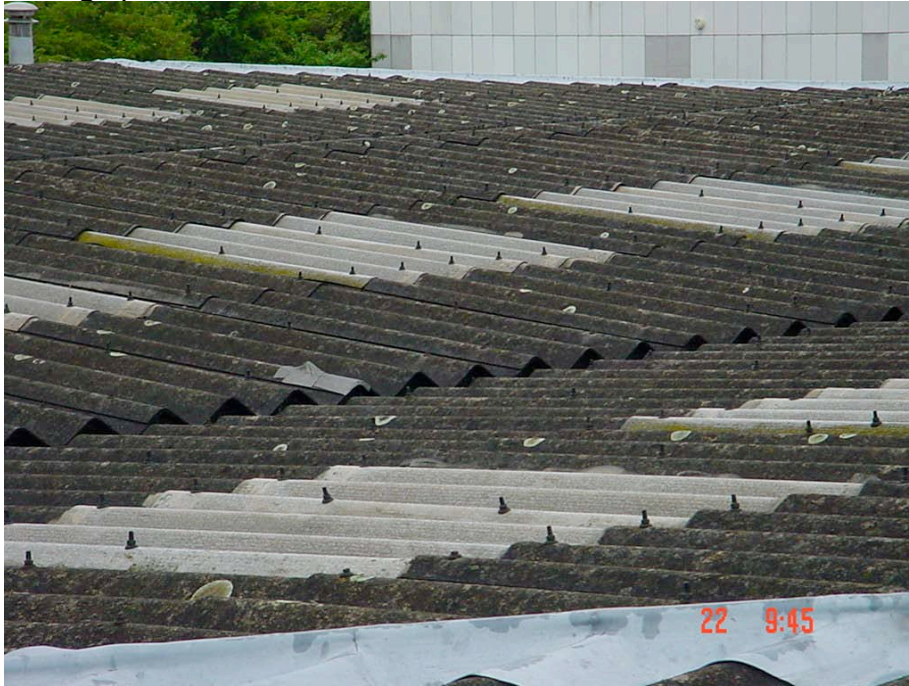
Photograph No 8.

Row 3 Roof light No 2. Flashb and repair to asbestos sheet.

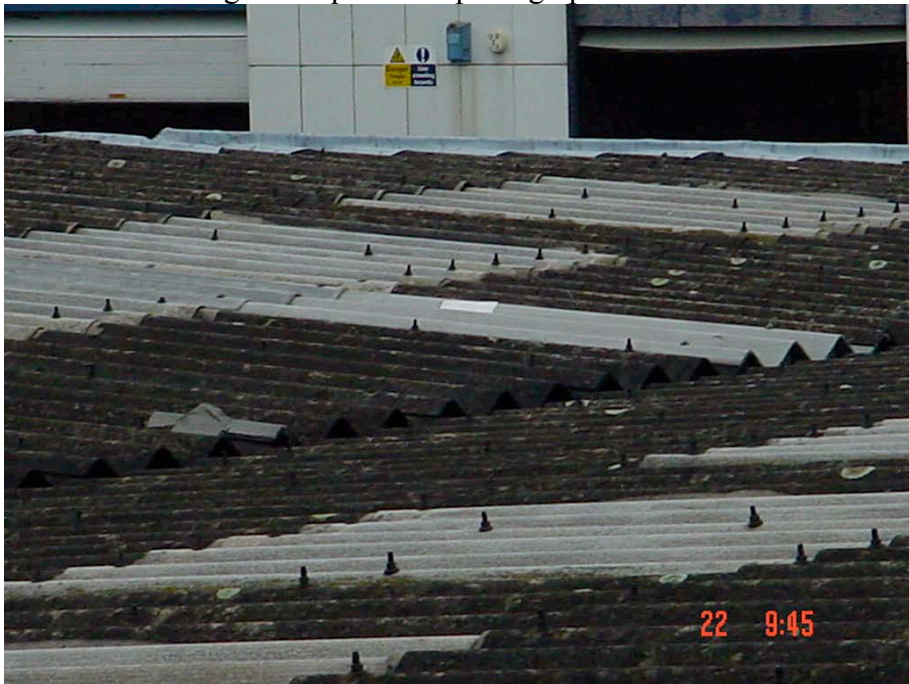
Row No 3. Roof lights 6 and 7. Approximately 5 No replacement asbestos sheets around and under roof lights. Flash band repair by valley gutter.

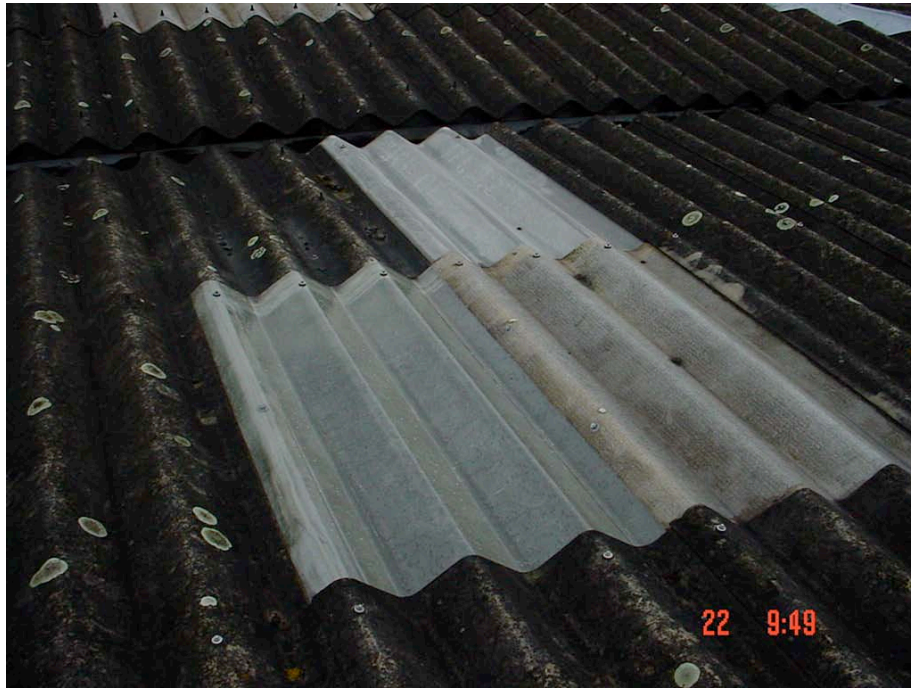
Photograph No 10.

Row No 4. Roof light No 7. New clear Roof light, with adjacent replacement asbestos sheet.

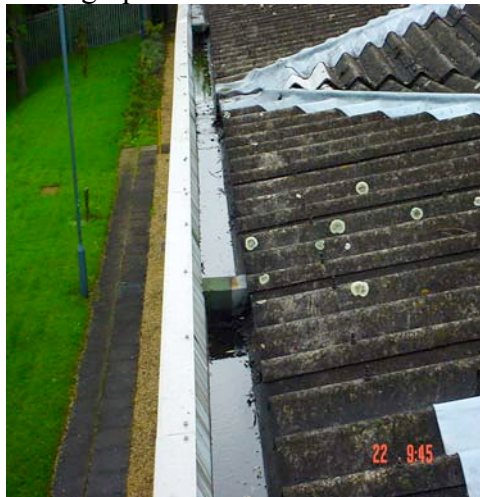
Photograph No 11.

Gutter to Front elevation

Gutters have been cleared but rain water holding in most areas.

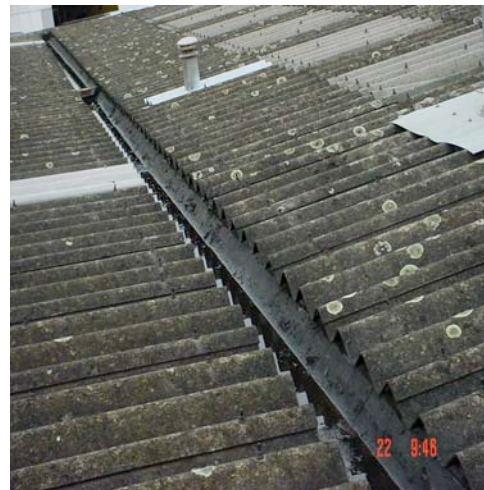
Photograph No 12

Gutter between Unit No 10 and 11.
