**COMMERCIAL BUILDING SURVEY**  
**OF**  
**The Tudor Rose Club,**

**FOR**  
**Mr S**

Firstly, may we thank you for your instructions of 28 November 2003; we have now undertaken a Commercial Building Survey (formerly known as a Structural Survey) of the aforementioned property. This Survey was carried out on 28 November 2003.

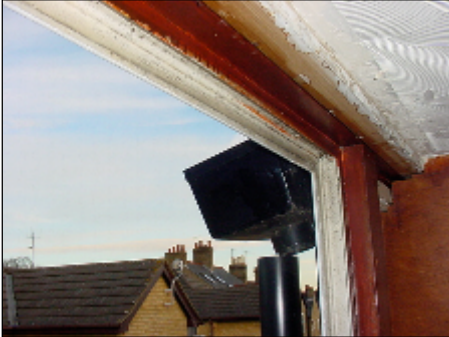
We found rot within the timber frame of the property. This is effectively a cladding because the strength of the property is set out within the steel frame and can be replaced, which does give you the opportunity to make the property more visually appealing/visually dramatic if you so wish, without major costs.

**ACTION REQUIRED:** In due course repair work will be necessary, but first the roof issues and the drainage via the rainwater gutters and downpipes needs to be resolved. These are fairly basic in some instances, such as re-fixing the hopperheads and downpipes.

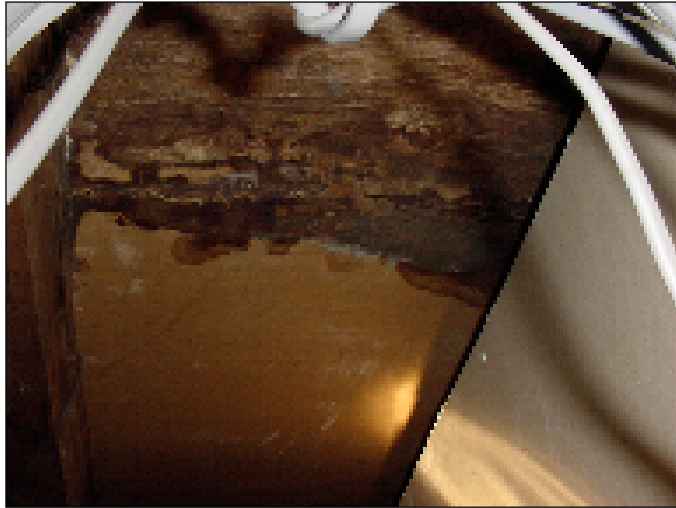
We were able to inspect the low level roofs through the suspended ceiling tiles, although our view was very limited. What we did see was what looked to be a wood decking, this looked to be damp in areas and we did note when walking on it that some areas were particularly spongy, indicating that water is getting through on to the decking itself.

Finally we would ask you to note that a general inspection of the roof timbers has not been possible as we could not access the roof for safety reasons (we do not think that the suspended ceiling tile system would take our weight). Our comments are based on our limited view. If you wish to err on the very cautious side we suggest that all the ceiling tiles are removed and a full inspection is carried out.

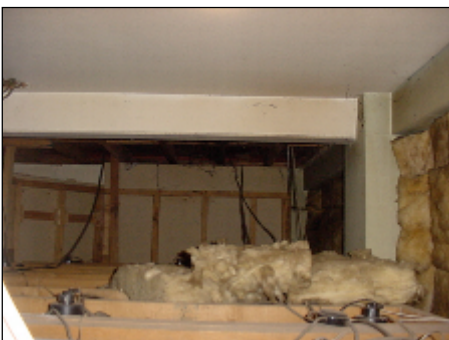
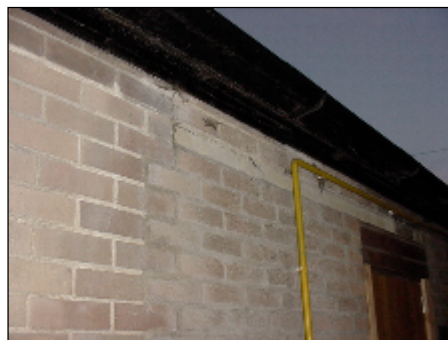
This part of the structure is built in brickwork in what is known as stretcher bond. We were going to say it was a cavity wall construction, however from the photo that we took from the ceiling of this section (below left) we believe that it may be on a steel frame, like the two-storey section of the property, and the brickwork is a cladding around it.

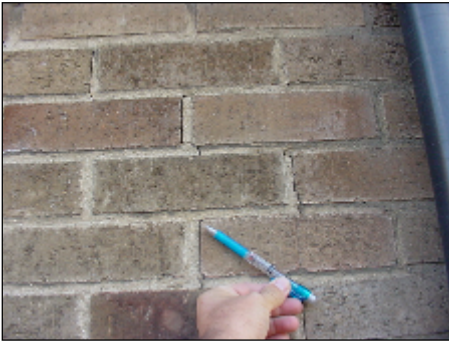
A diagonal hairline crack was found to the far right hand corner of the brickwork at the front of the building. We believe this may relate to water coming in via the flat roof. We stress this is very minor.

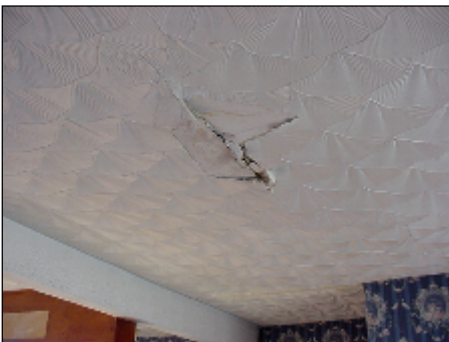
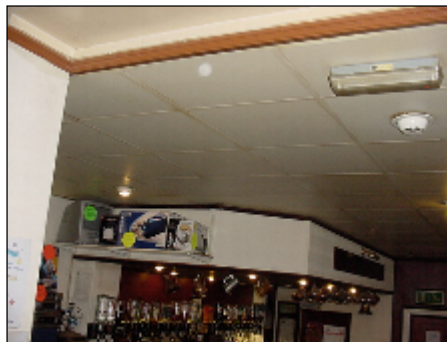
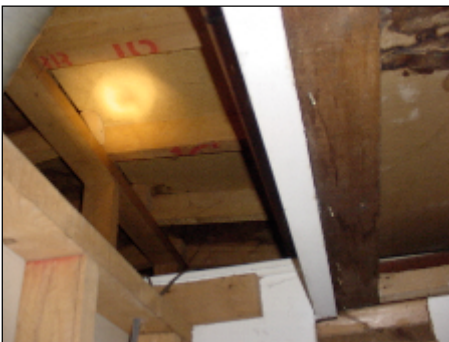
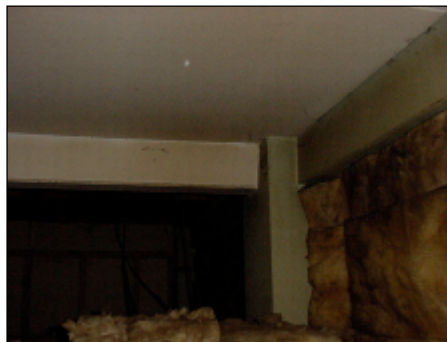
We have only been able to access the ceiling in the corridor area near the bar. Here there is a suspended ceiling system, this is usually attached via a wire suspension system to either the decking, the steel frame or timber joists. As a general comment there is damage to some of the ceilings, for example to the first floor bar area there is water damage, where the water has literally come through the roof, and there are tiles damaged and missing to the suspended ceiling system on the ground floor.

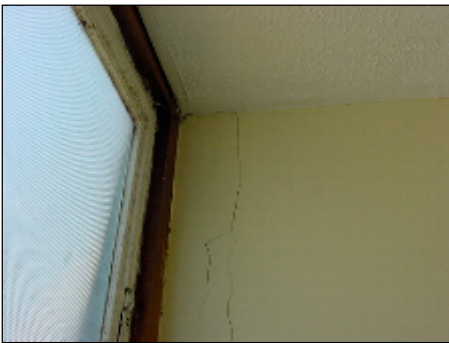
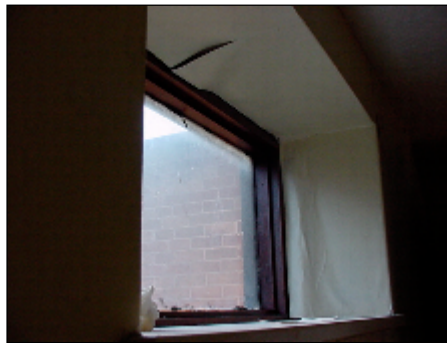
There is general marking and impact damage to the walls, scuffing etc, but nothing that we feel is particularly unusual for this type of property and that would fall under the general re-decoration and making good or refurbishment heading.

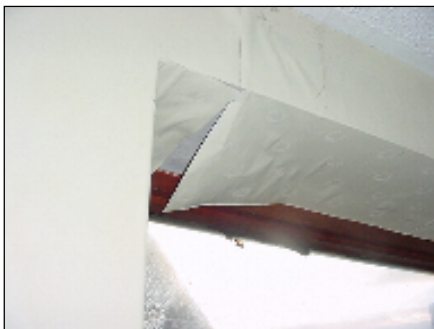
There were signs of dampness to some of the internal walls. We believe this is probably coming through the roof to the higher levels and through the cladding, particularly to the timber sections in the other areas.

You really need to work from the top of the structure down to make it watertight, preparing the roof as we have mentioned earlier, then the gutters, then looking at the cladding. This should then resolve the lateral or penetrating dampness.

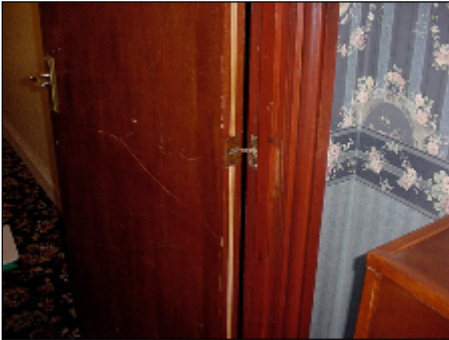
You have a mixture of panel doors throughout. We noted some of them to be marked and scuffed etc, as you would expect in a building of this type. We noted that some appeared to be missing door closers and we feel there may be a need for an additional fire door to the base of the staircase, if you intend to use the upper floor.

A good idea is to ask the Fire Brigade to take a walk around the property with you and carry out their recommendations.

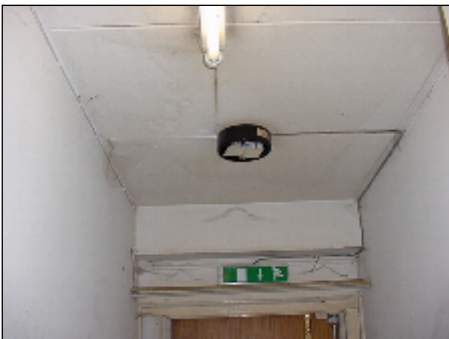
As commented in the Executive Summary of this report, although we are advised that it meets current Fire Regulations, there are various items that we noted that we do not feel would meet these Regulations. We therefore recommend that you have an 'off the record' conversation with the local Fire Brigade to establish whether they are happy with the present arrangement and if they have made any recommendations that have or have not been carried out.
