SCHEDULE OF CONDITION

The White Hart

The Schedule of Condition has been prepared by www.1stassociated.co.uk in October 2002. The inspection was carried out on Wednesday 9 October 2002 and this report does not constitute a Structural Survey (now known as a Building Survey).

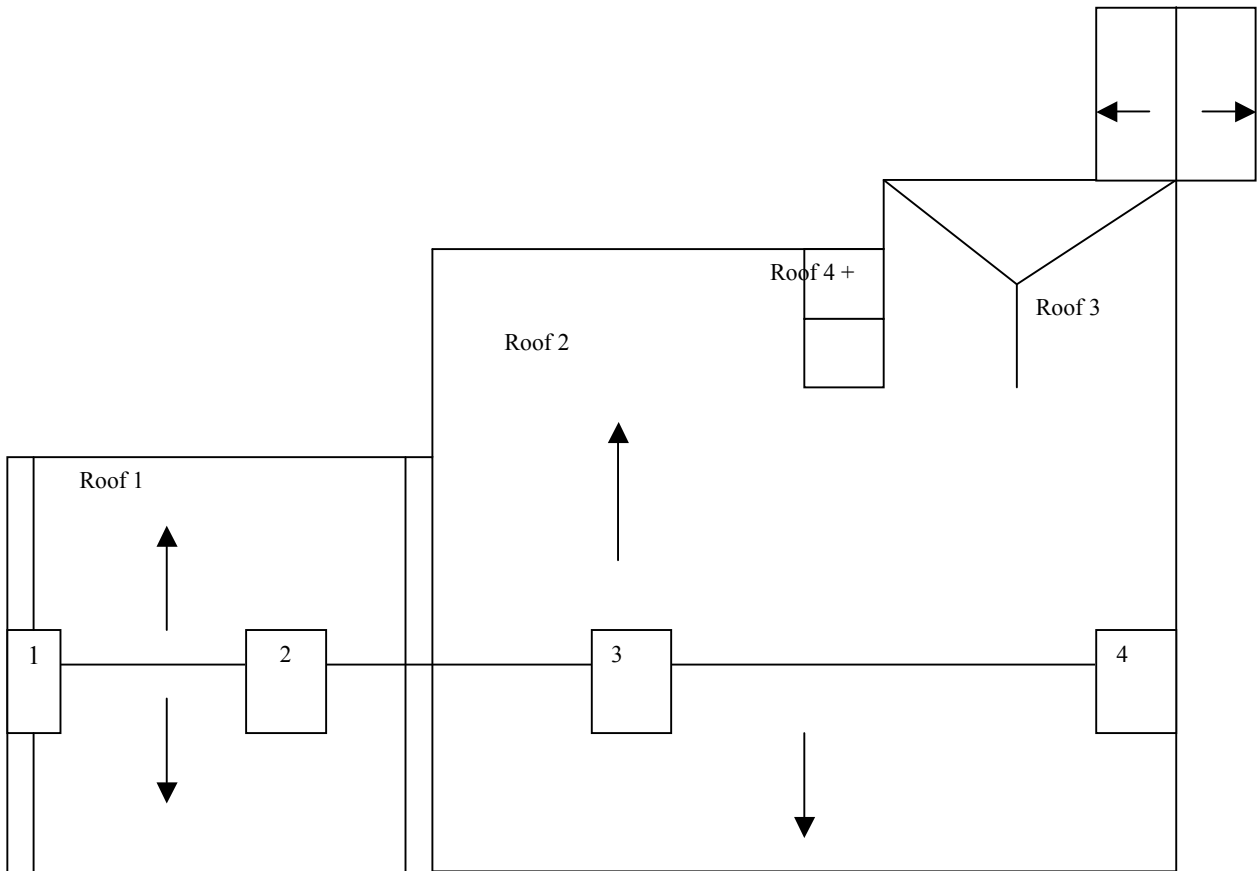
EXTERNAL ROOF PLAN

Slight lean, requires extensive re-pointing and a crack visible.

A fairly steep pantile roof in reasonable condition.

A blackened pantile in average condition. There are some displaced tiles to the left hand side and the ridge requires re-bedding.

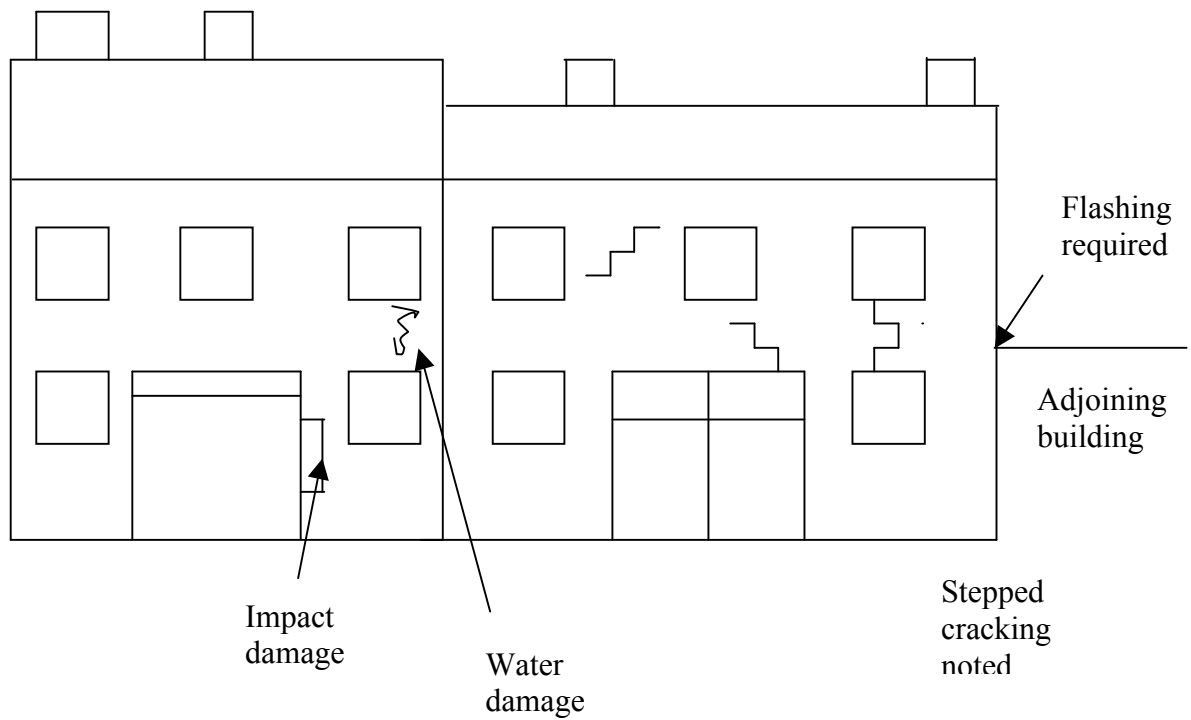
FRONT ELEVATION – LEFT HAND SIDE

This sketch shows a sample of the problems and issues identified.

Generally painted Flemish bond brickwork. The paintwork is dirty discoloured and flaking. Water damage from the overflowing gutter is also visible.

Various step cracks were noted, particularly to the right hand side and there is also impact damage to the sides of the coach way arch.

ACTION: Repair guttering already mentioned. We have assumed that the step cracking is historic.

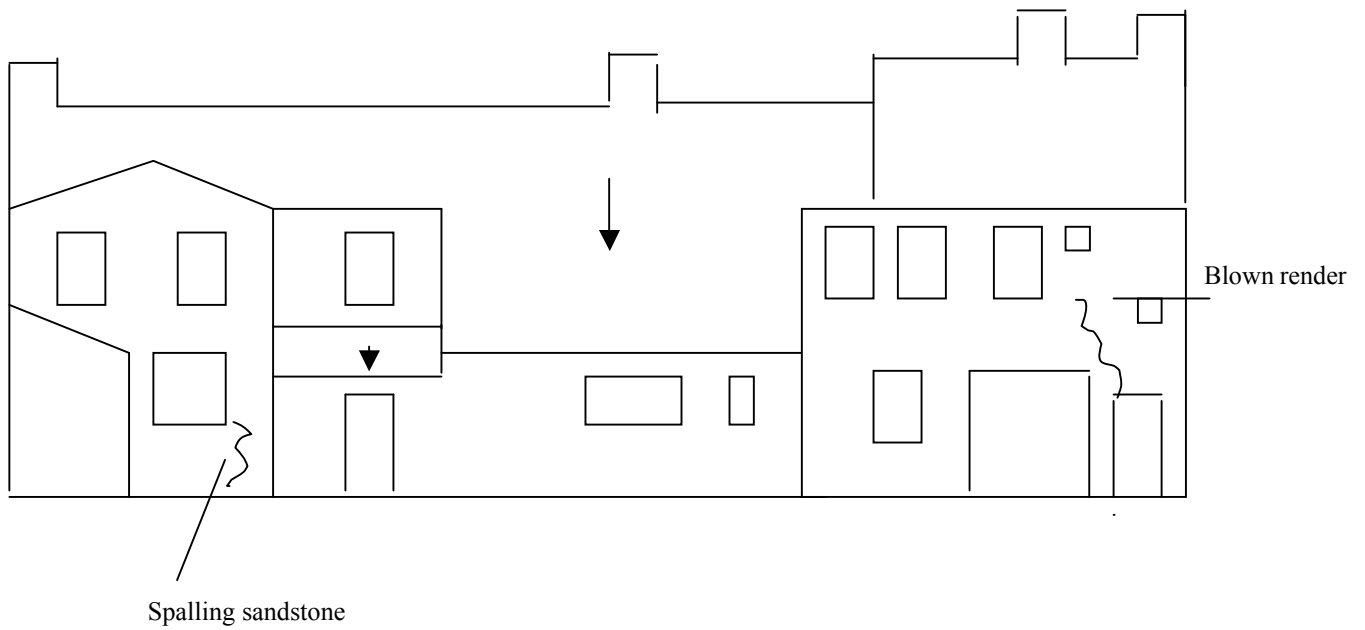
REAR ELEVATION

This sketch drawing shows a sample of the problems and issues identified.

We also note that the building has a Listed sign on it, which indicates that future repairs will be monitored and may require specifications over and above those that have been previously used, for example the render appears to be cement based when the render for this age of property will have been lime based.

ACTION: Hack off hollow areas of render and replace. From our investigations of the area to the right hand side of the bed and breakfast entrance door we anticipate the render will be approximately 50% of the entire render area.

Whilst there is no obvious initial need to carry out this work we would anticipate it as being a future cost. Estimate of repair work cost £5,000 to £10,000.
