**Prelease  
Schedule of Condition and Want of Repairs  
at  
Milton Keynes  
for  
May**

To carry out Inspection of the Industrial Unit, to identify areas of repair to the Unit at commencement of the Lease.

**Schedule of Condition and Want of Repairs  
at  
Milton Keynes**

Addendum to original Report with photographs

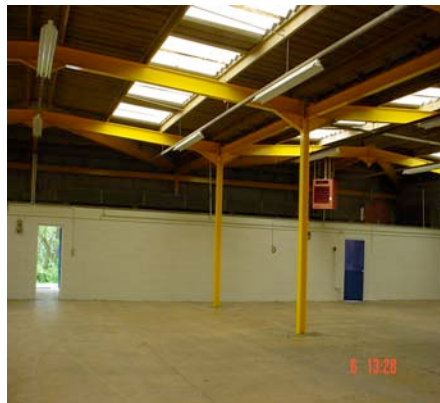
Open Area facing Offices [ view through to Foyer]

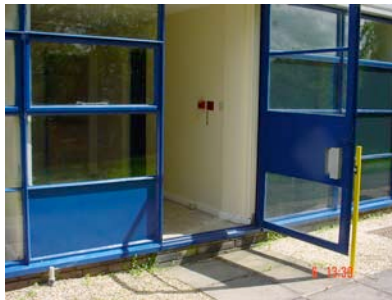
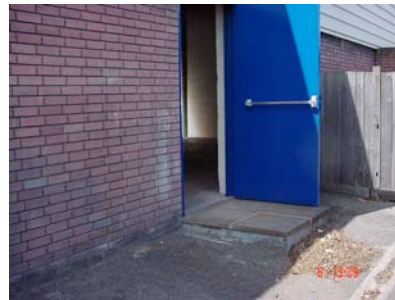
The main pedestrian access is by the wide glazed door to the Front elevation, but this has a step, to provide a ramp to this door may be outside your demised area, and may require the Landlord to carry out this work, while the Emergency exit is within your demised area, should ramps be found to be necessary.

Under the Disabled Discrimination Act 1995, all properties must have, by 1<sup>st</sup> October 2004, reasonable adjustments including physical access, for all persons be they public or employees, as it is unlawful to treat them less favourably than other people. This may include Disabled toilets if such people are employed. We can advise further should you require additional information.
